MISCELLANEOUS PAPER S-68-13

**MEMBRANE - ENVELOPE TECHNIQUE FOR
WATERPROOFING SOIL BASE COURSES
FOR AIRSTRIPS
BARE BASE SUPPORT**

July 1968

Conducted by
**U. S. Army Engineer Waterways Experiment Station
CORPS OF ENGINEERS
Vicksburg, Mississippi**

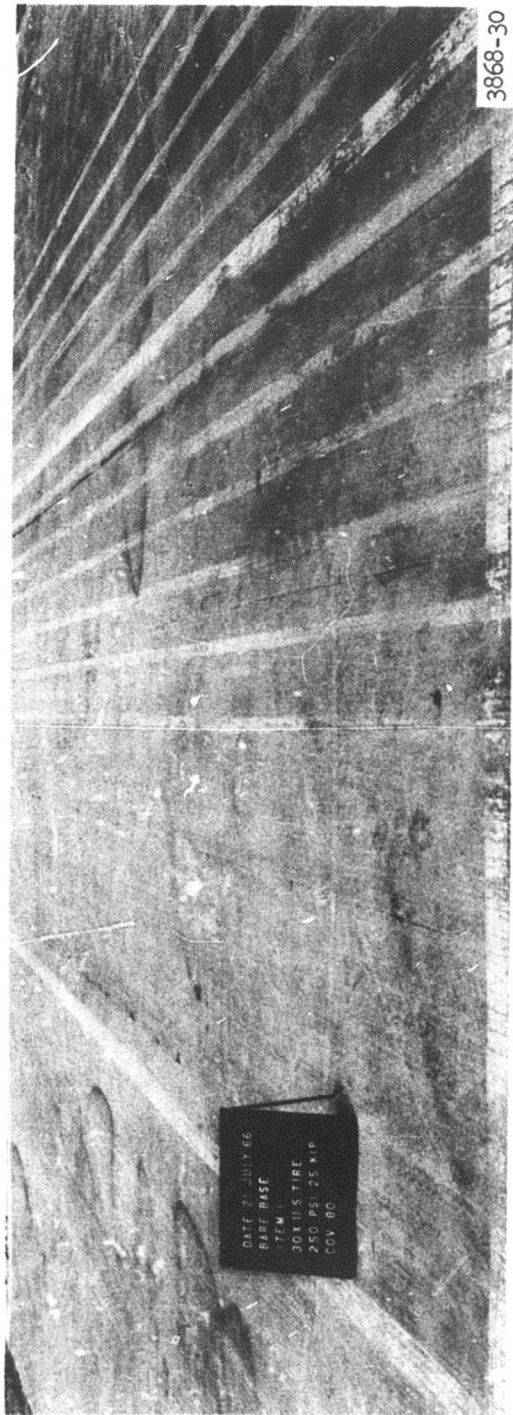
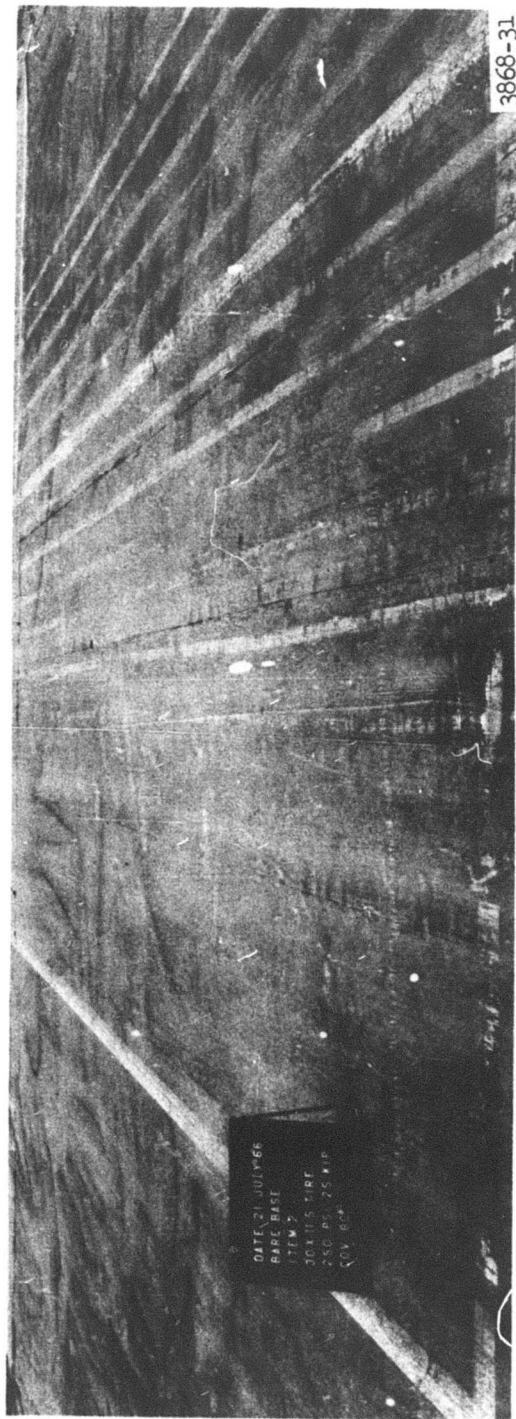
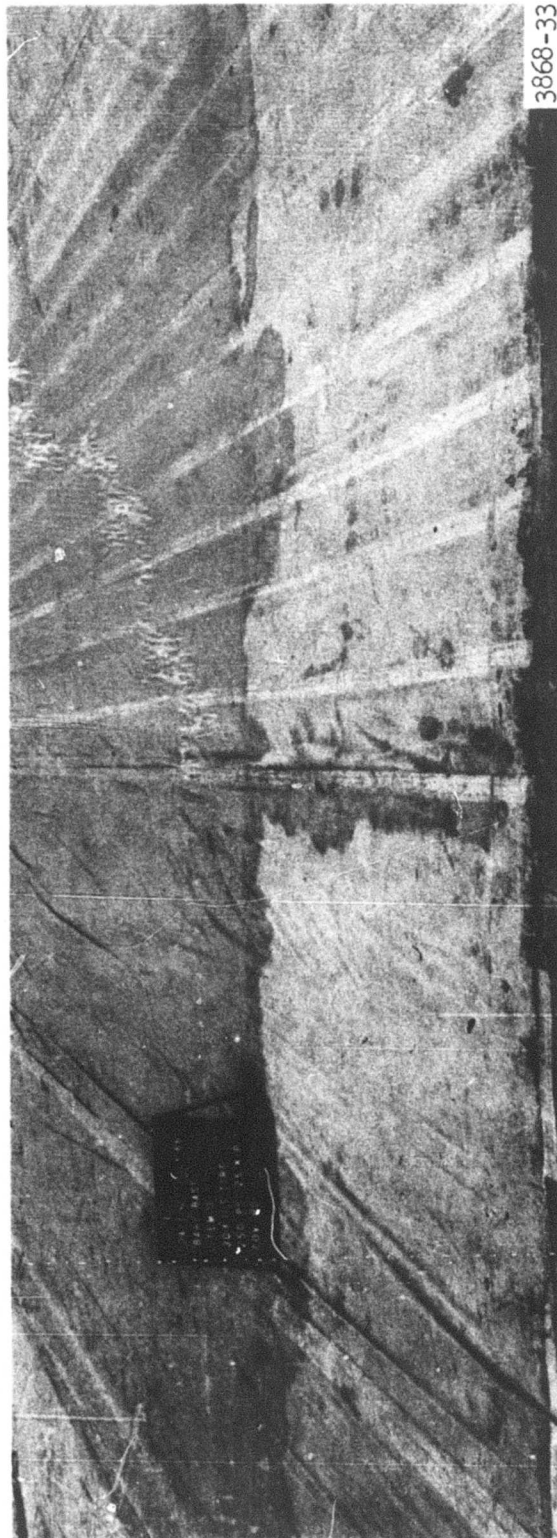
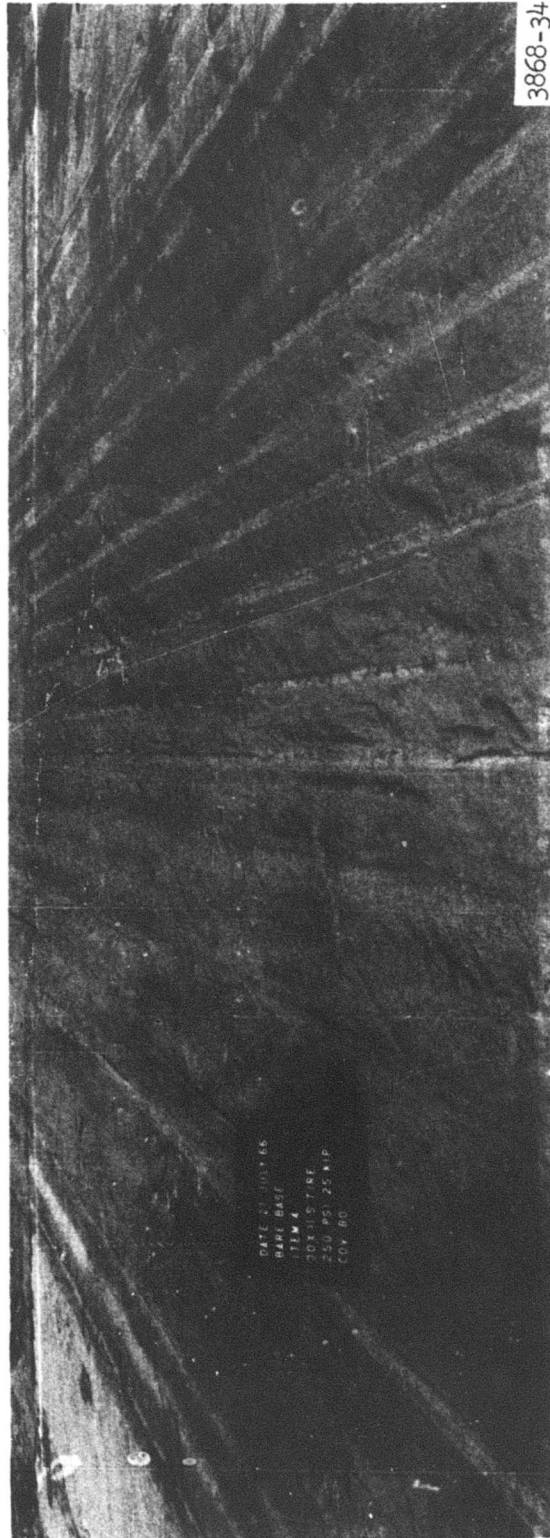
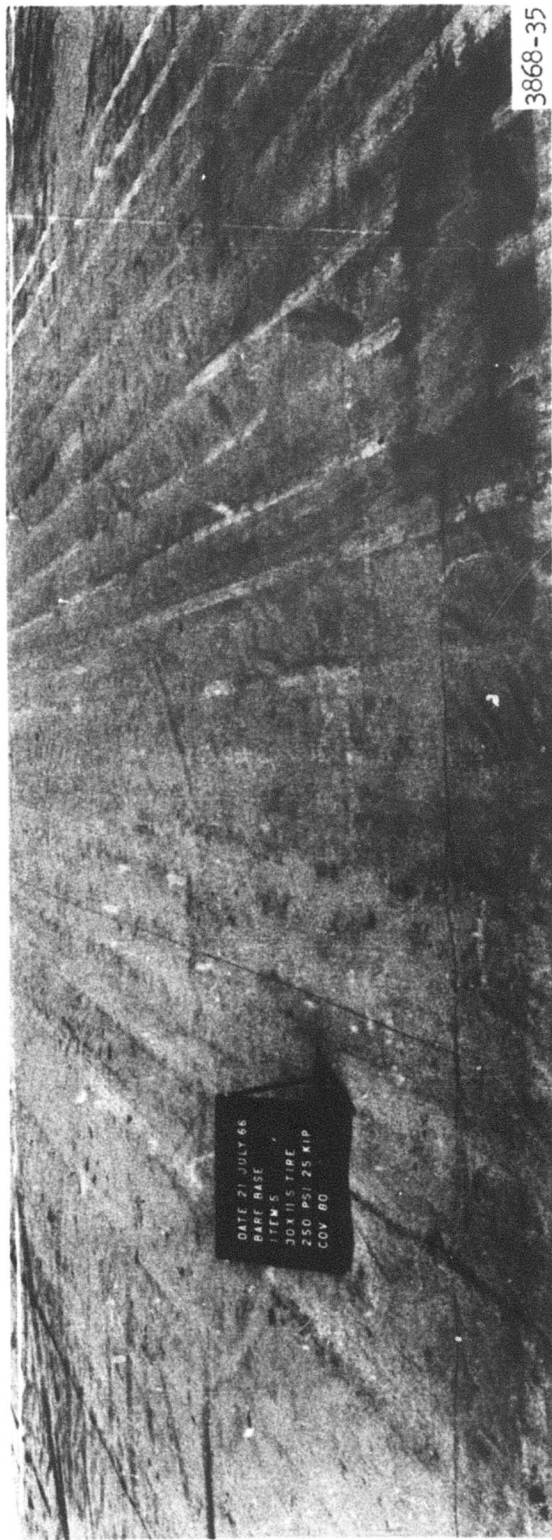
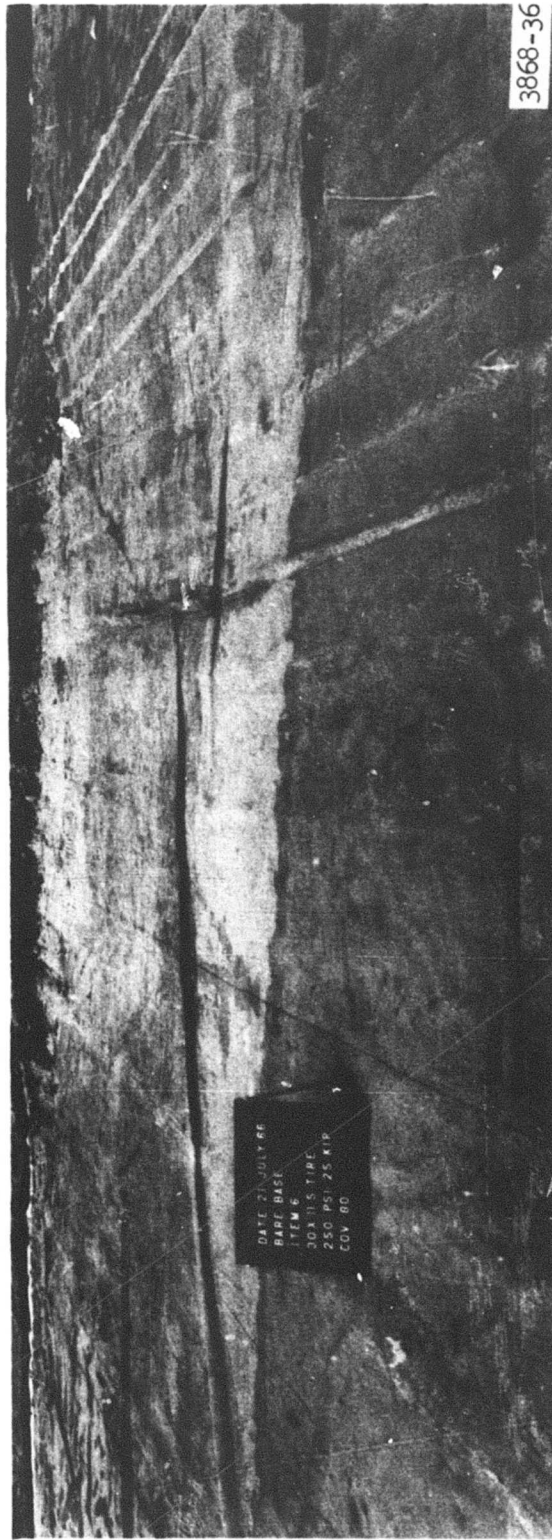
43. Four more coverages (cumulative total 80) were applied on 21 July, and it was again necessary to make repairs to the longitudinal joints in the T2 membrane. Views of items 1-6 after 80 coverages are shown in photographs 14-16.

Photograph 14. Items 1 and 2 after 80 coverages

Photograph 15. Items 3 and 4 after 80 coverages

Photograph 16. Items 5 and 6 after 80 coverages

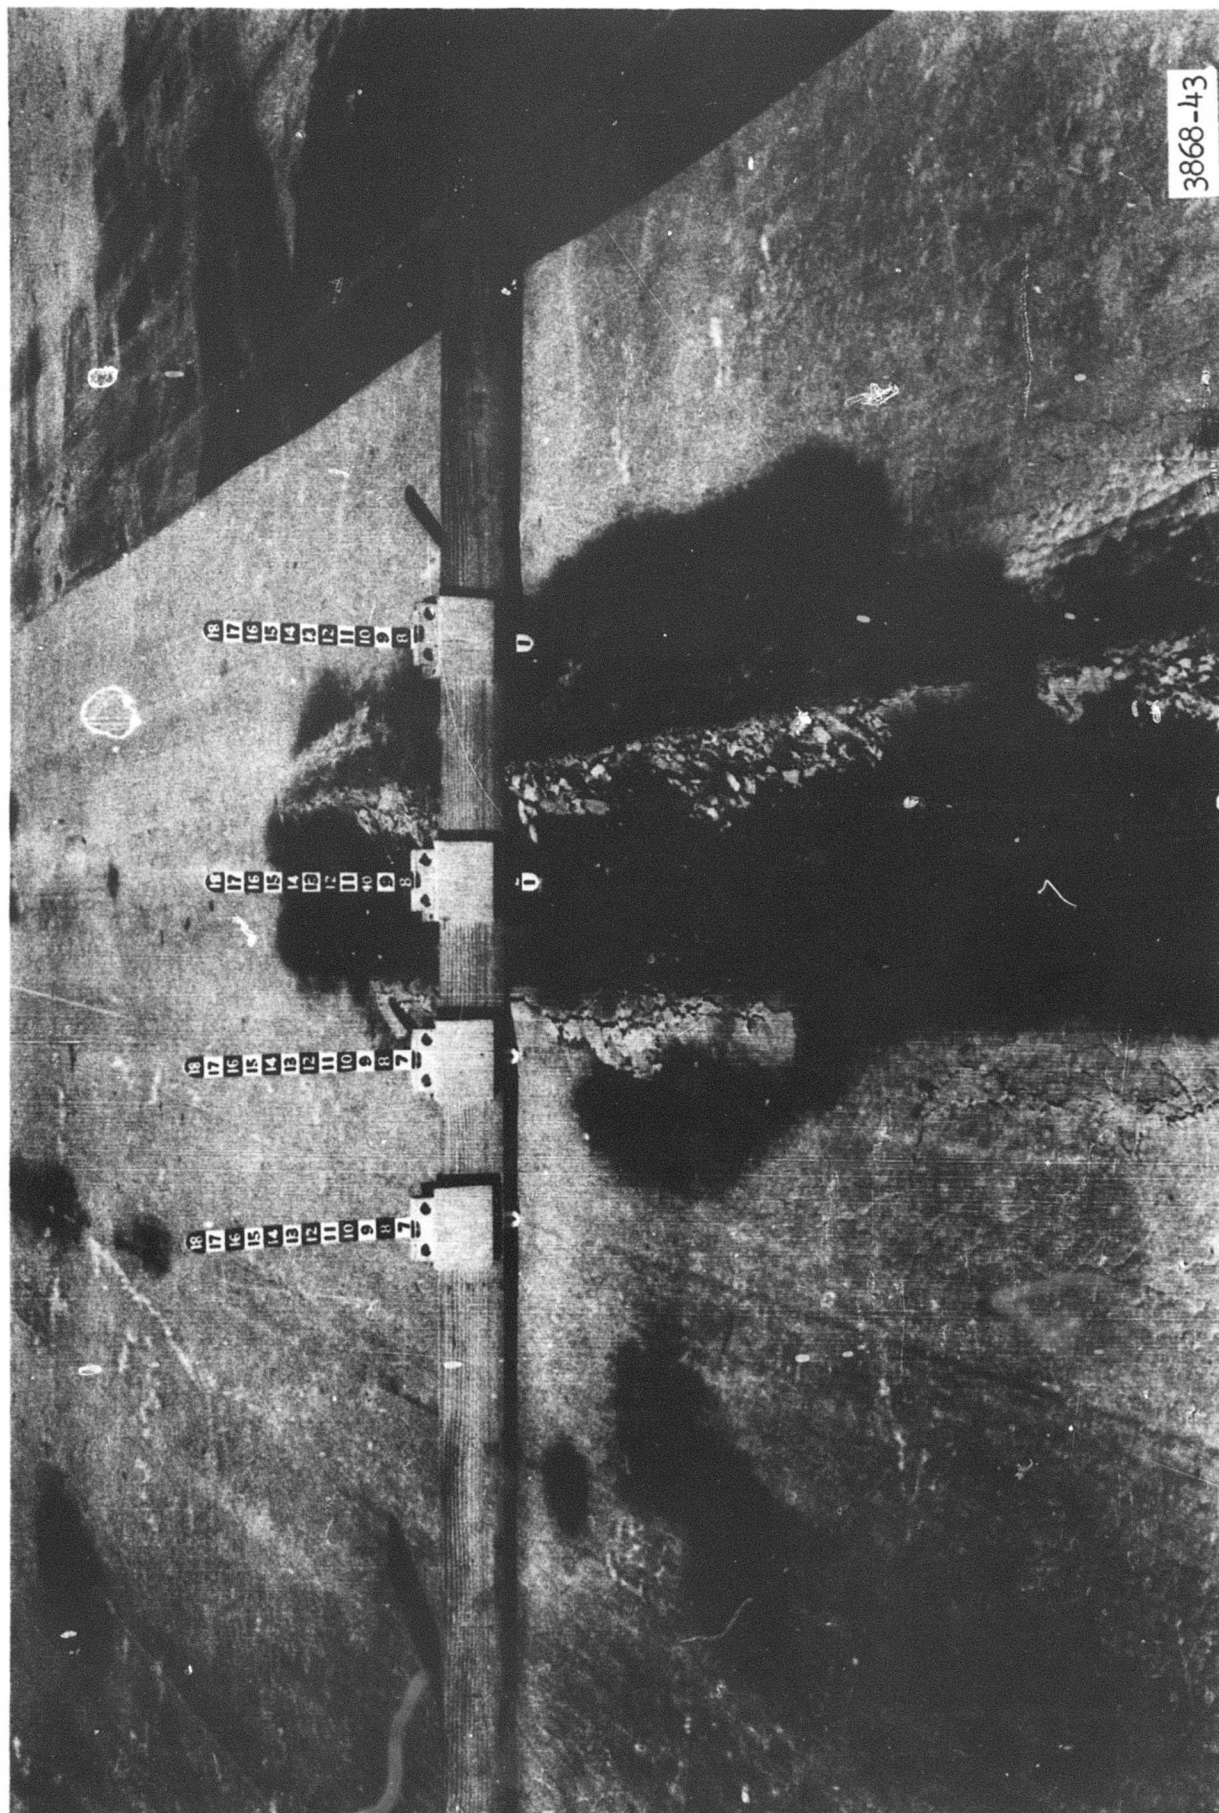
45. On 28 July, 22 coverages of traffic were applied to the test section making a cumulative total of 102 coverages. During this period, several soft areas and ruts began to develop in items 1 and 2 as a result of prior water seepage through openings in the longitudinal joints. Therefore, the membrane was cut along the outside of the traffic lane and pulled back to expose the base soil for repairs. A view of a rutted area in item 1 after 102 coverages is shown in photograph 17. From this photograph it can be seen that the rutted area was relatively small and that generally the item was dry and the base soil quite hard. Tests at this time indicated typical soil surface strength and water content in item 1 to be 67 CBR and 10 percent, respectively. In the rutted areas, soil strength and water content averaged 14 CBR and 15.8 percent, respectively. After the wet soil had been removed and replaced, the membrane was replaced and resealed. At this time, items 3-6 were in excellent condition. An additional 18 coverages of traffic were applied on 29 July, with little change in the test section. The total traffic that had been applied at this time was 120 coverages.

Photograph 17. Rutted area in item 1 base after 102 coverages

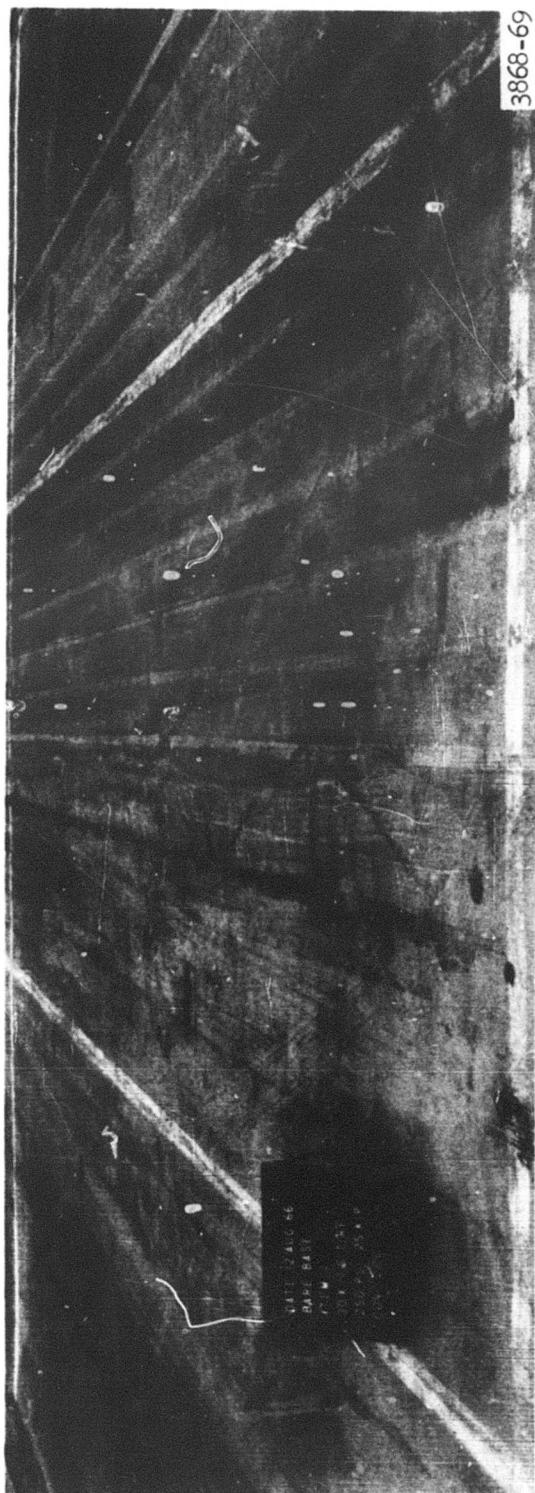
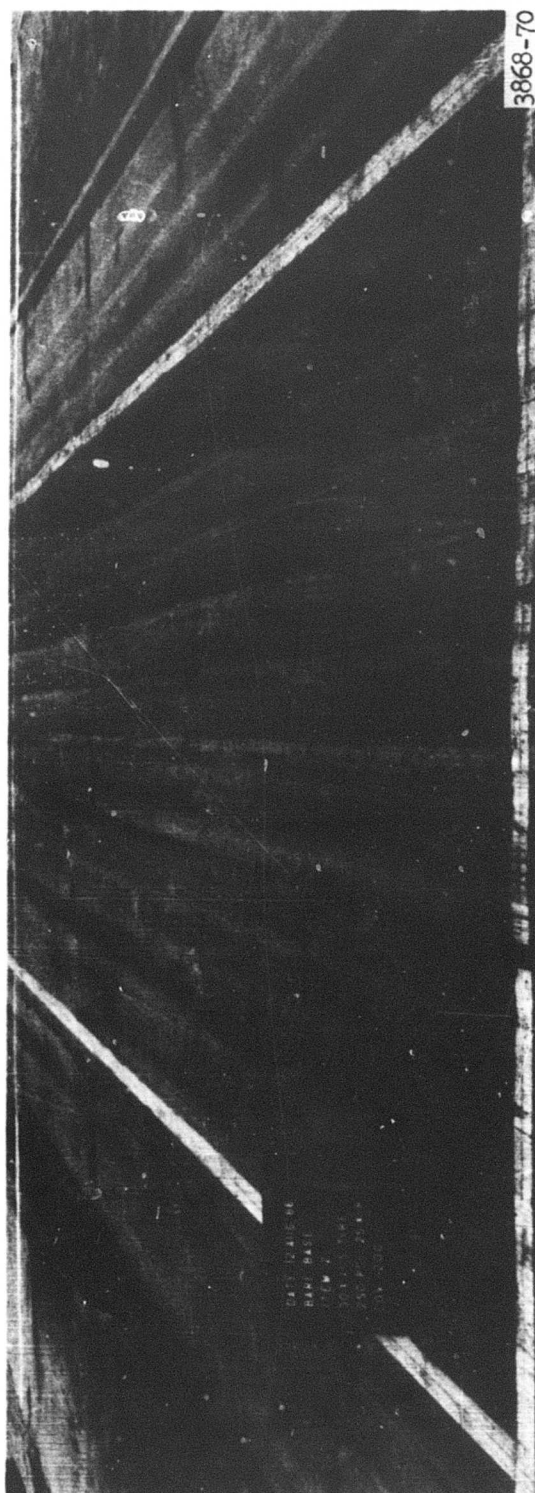
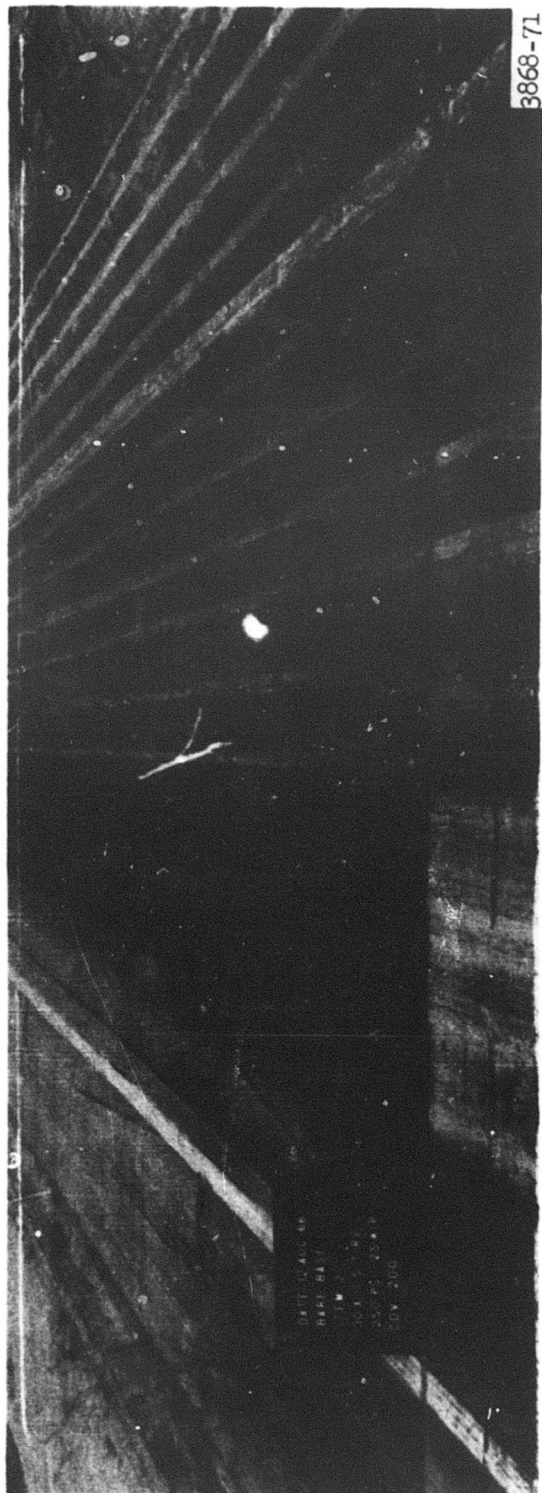
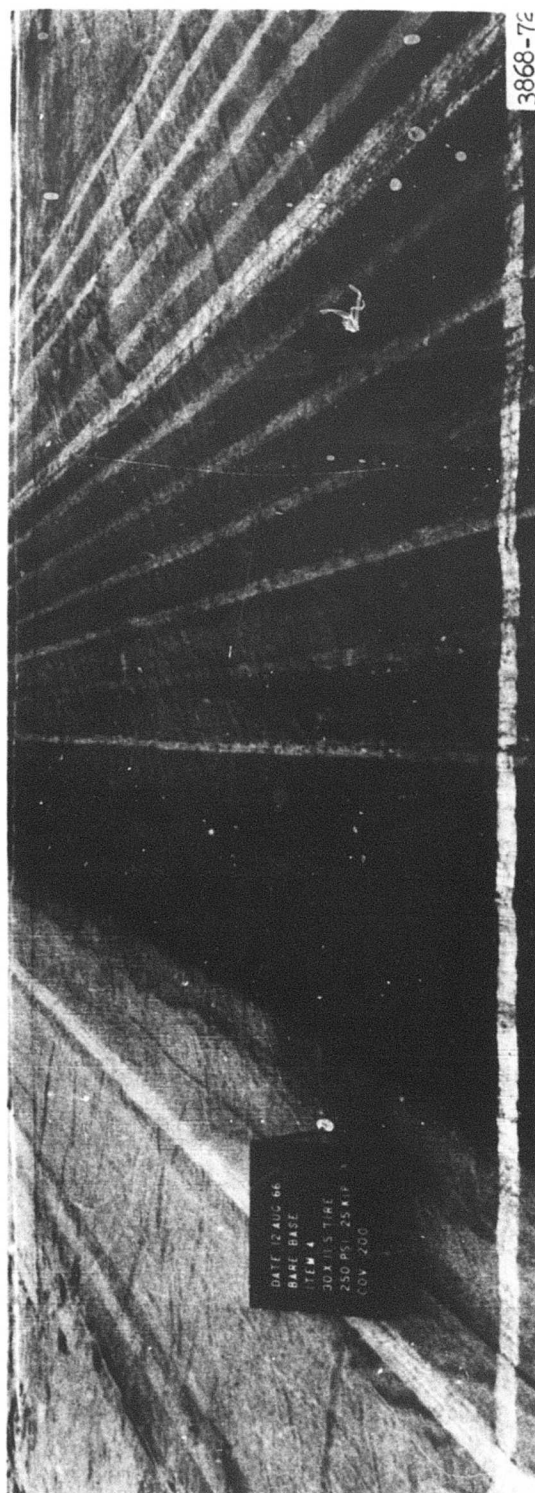
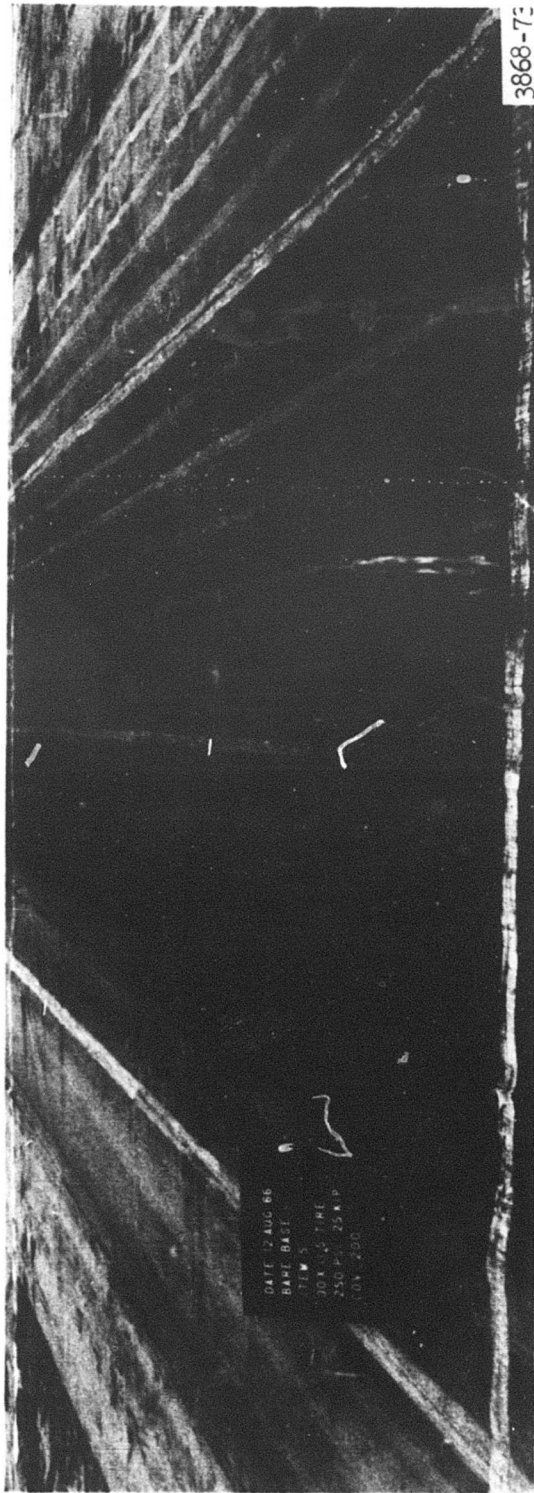
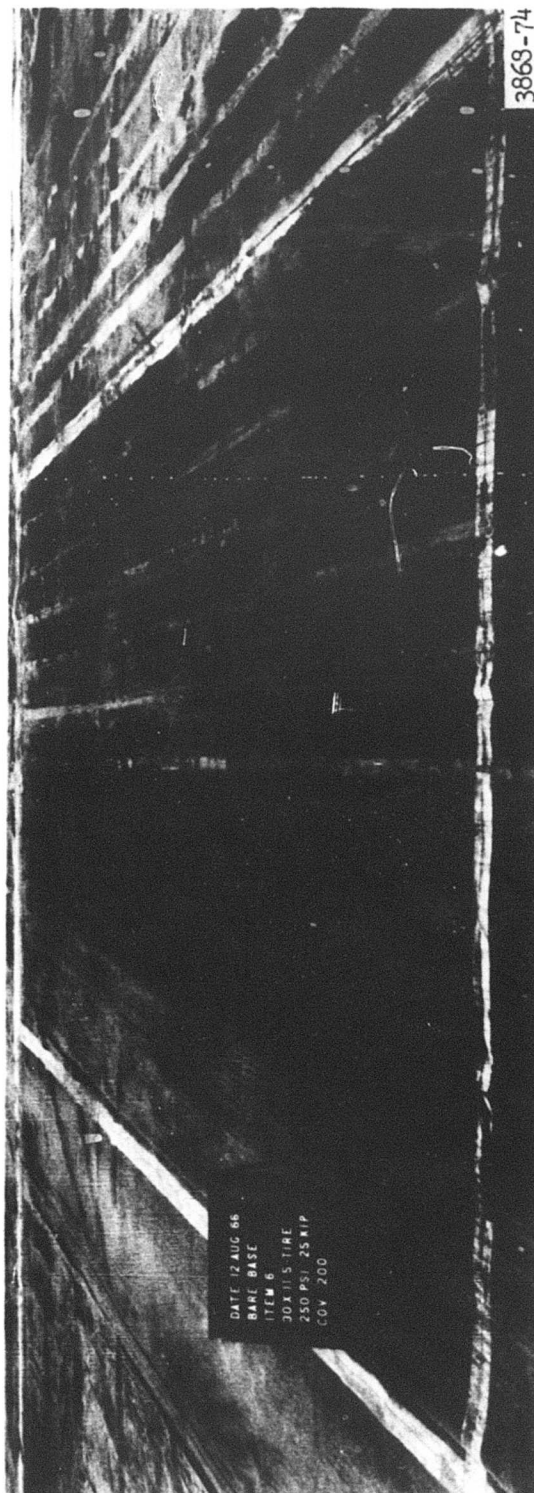
section, making a cumulative total of 160 coverages. During this period, it was necessary to make repairs to the T1 membrane in items 1 and 2 several times due to glue failure in the longitudinal joints. No difficulties were experienced with either the T16 or T17 membranes. On 11 August, the test section received an additional 40 coverages (total 200), part of which was applied during rain showers. After the first two coverages had been applied, ruts began to develop in isolated spots in items 1 and 2 as a result of the base soil's getting wet from water leakage through openings in the longitudinal joints. At 200 coverages (cumulative), traffic was stopped, and repairs were made to the base and membrane in items 1 and 2. Items 3-6 were in excellent condition. Views of items 1-6 after 200 coverages are shown in photographs 18-20.

Photograph 18. Items 1 and 2 after 200 coverages

Photograph 19. Items 3 and 4 after 200 coverages

Photograph 20. Items 5 and 6 after 200 coverages

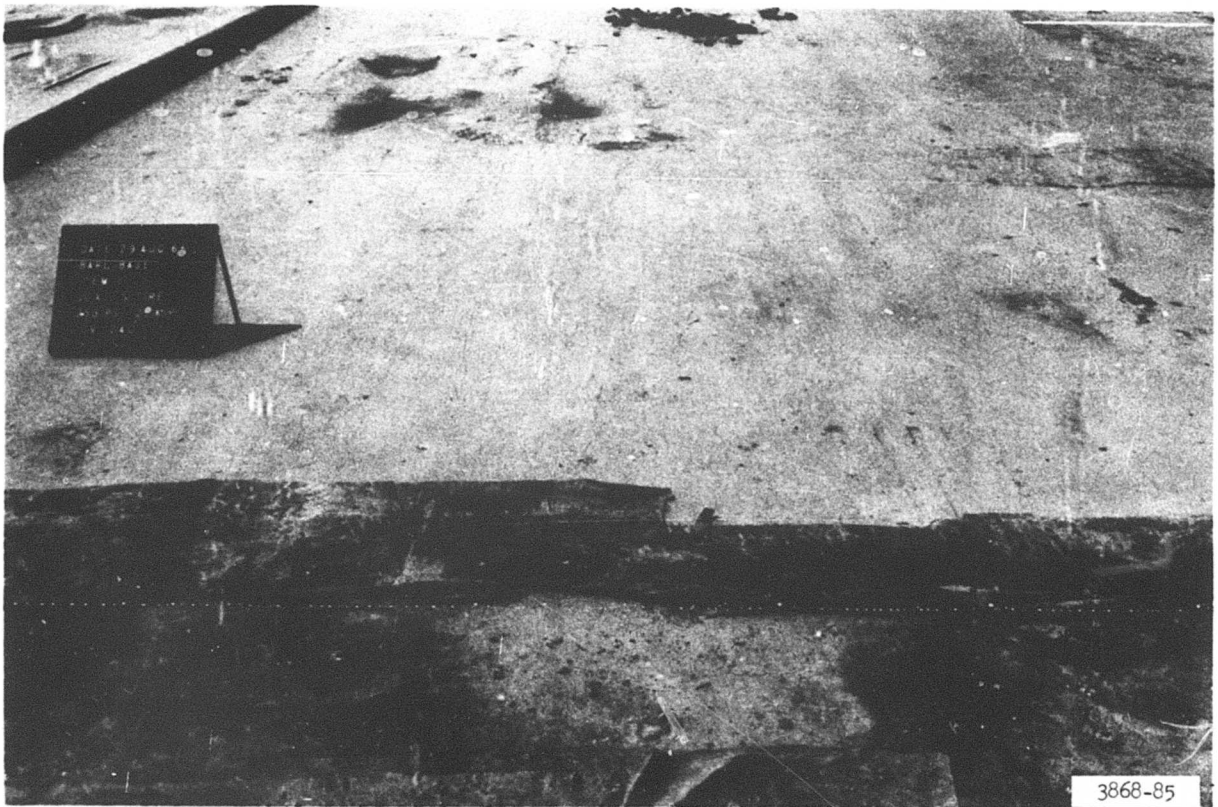
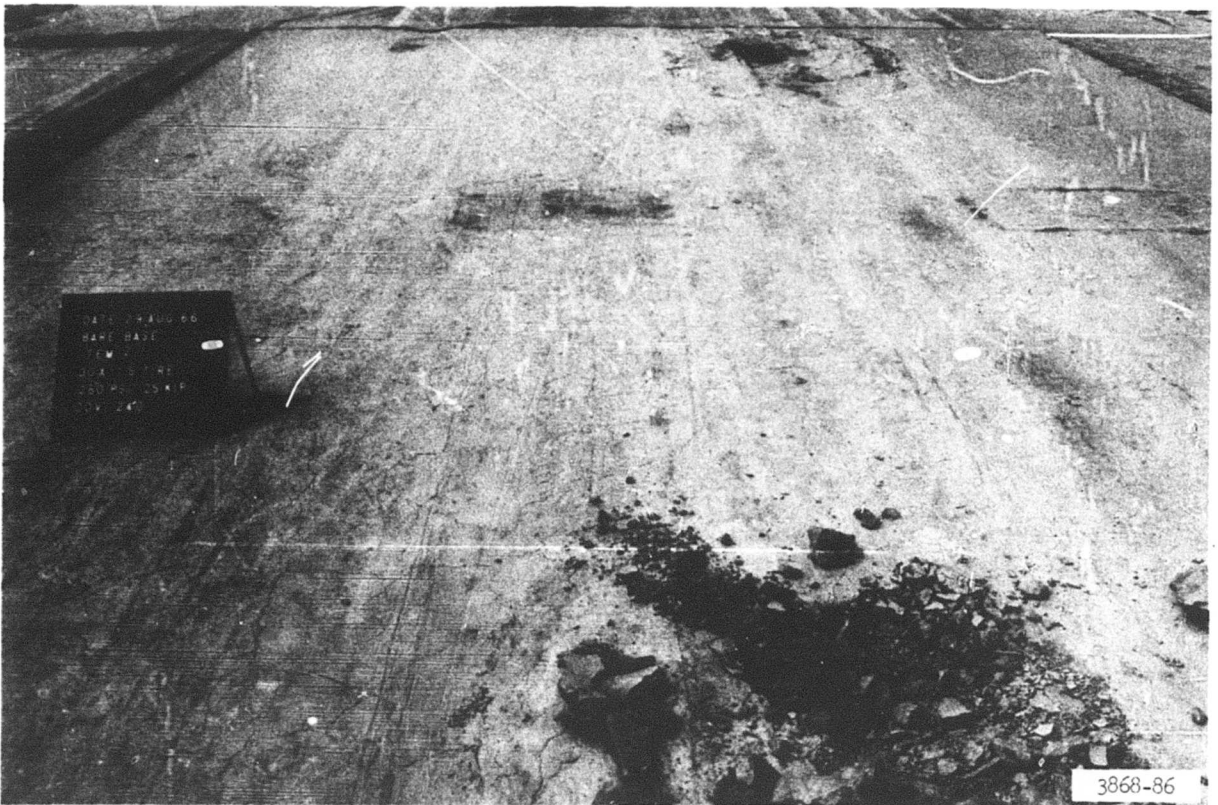
Photograph 21. Base in items 1 and 2 exposed after 240 coverages

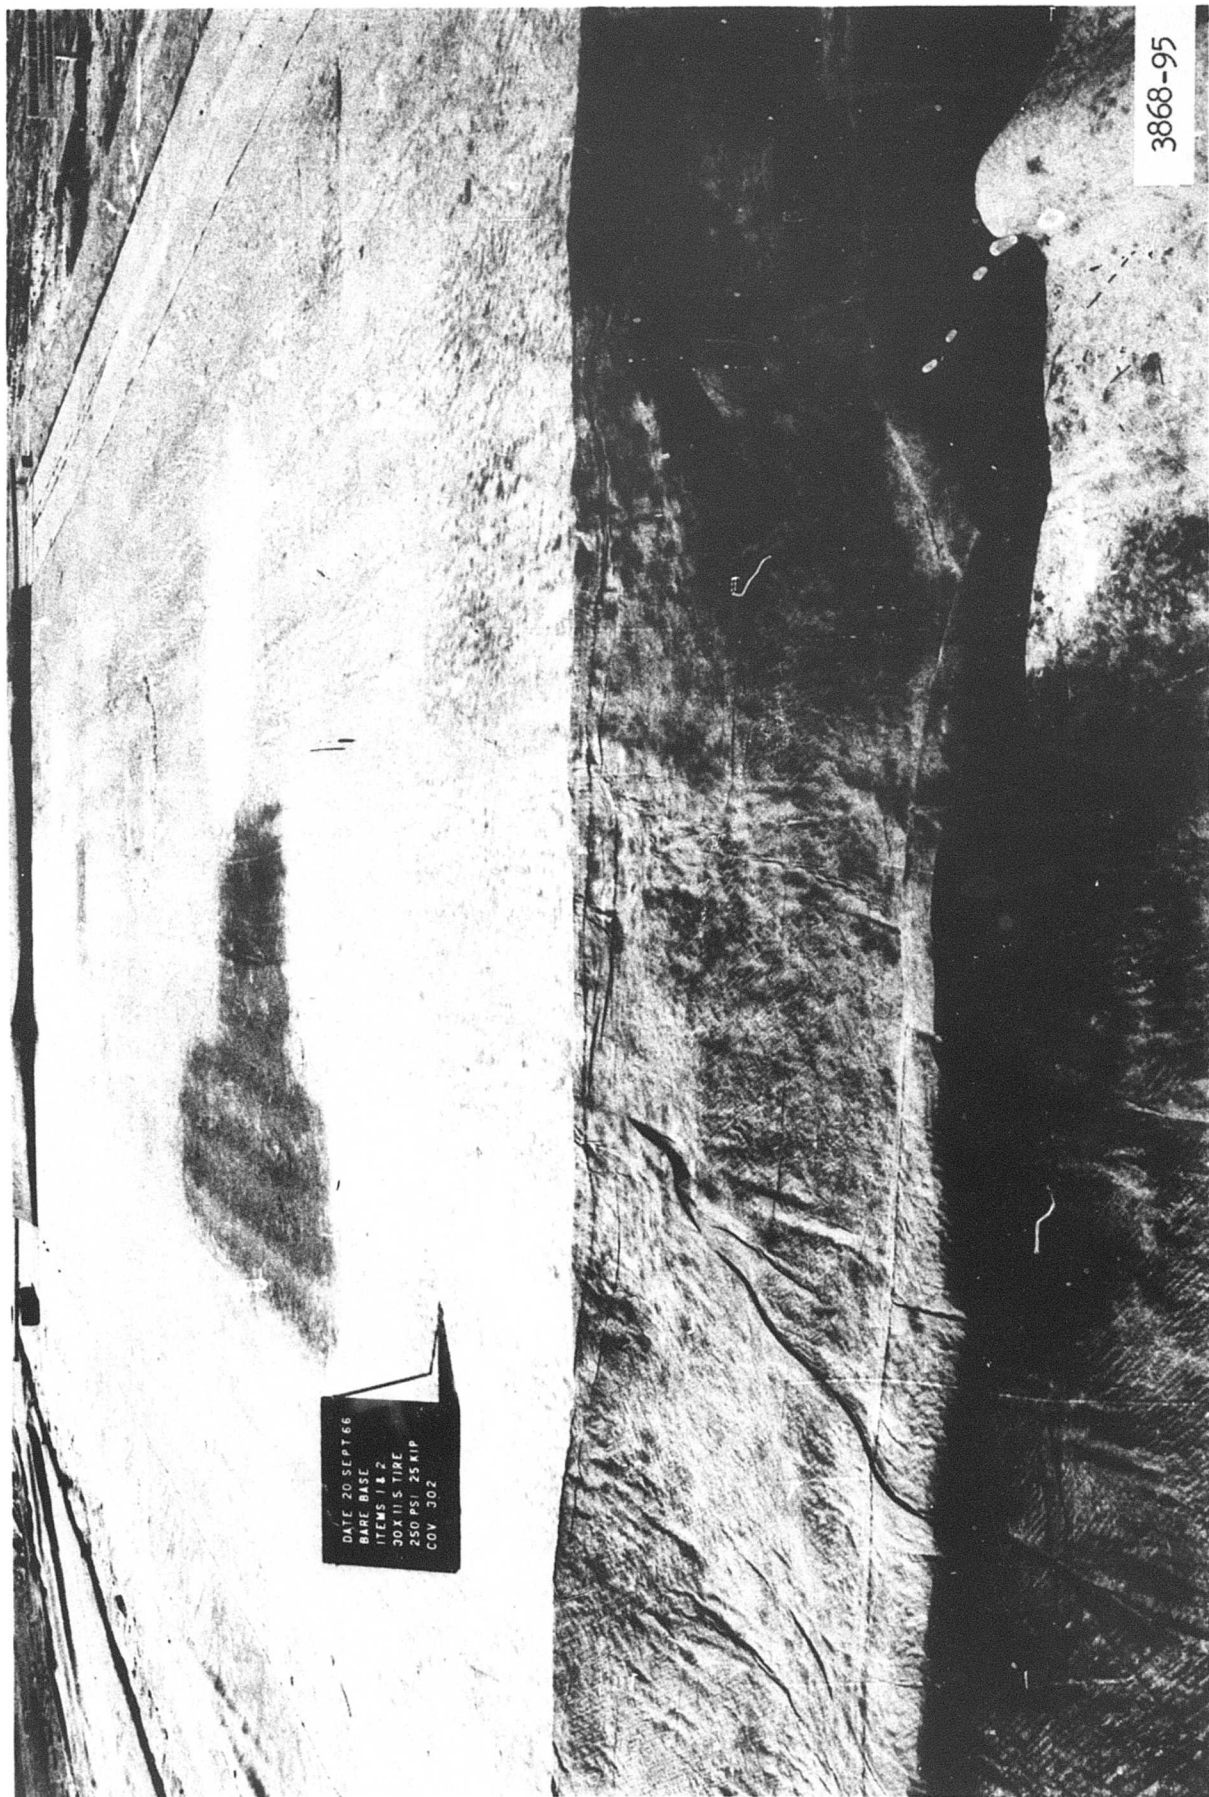
Photograph 22. Base in items 1 and 2 exposed after 302 coverages

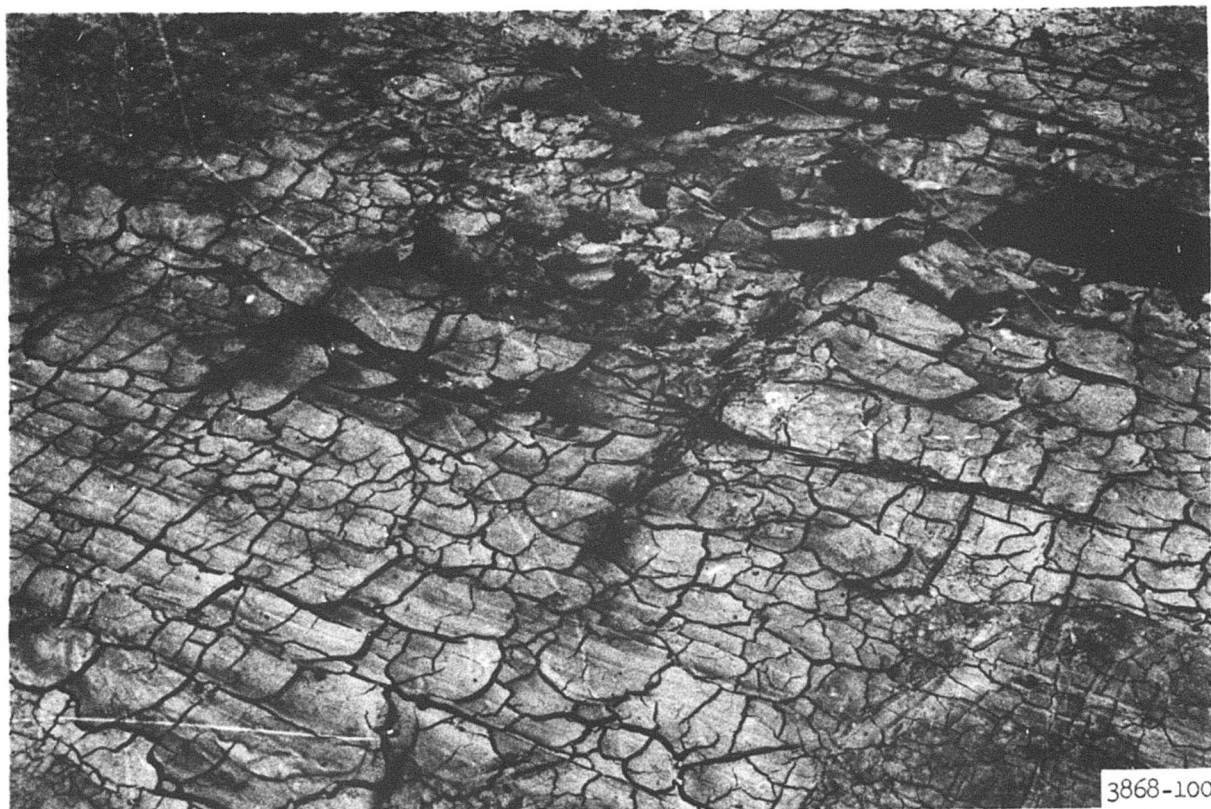
Photograph 23. Isolated wet spot in item 5 at 302 coverages

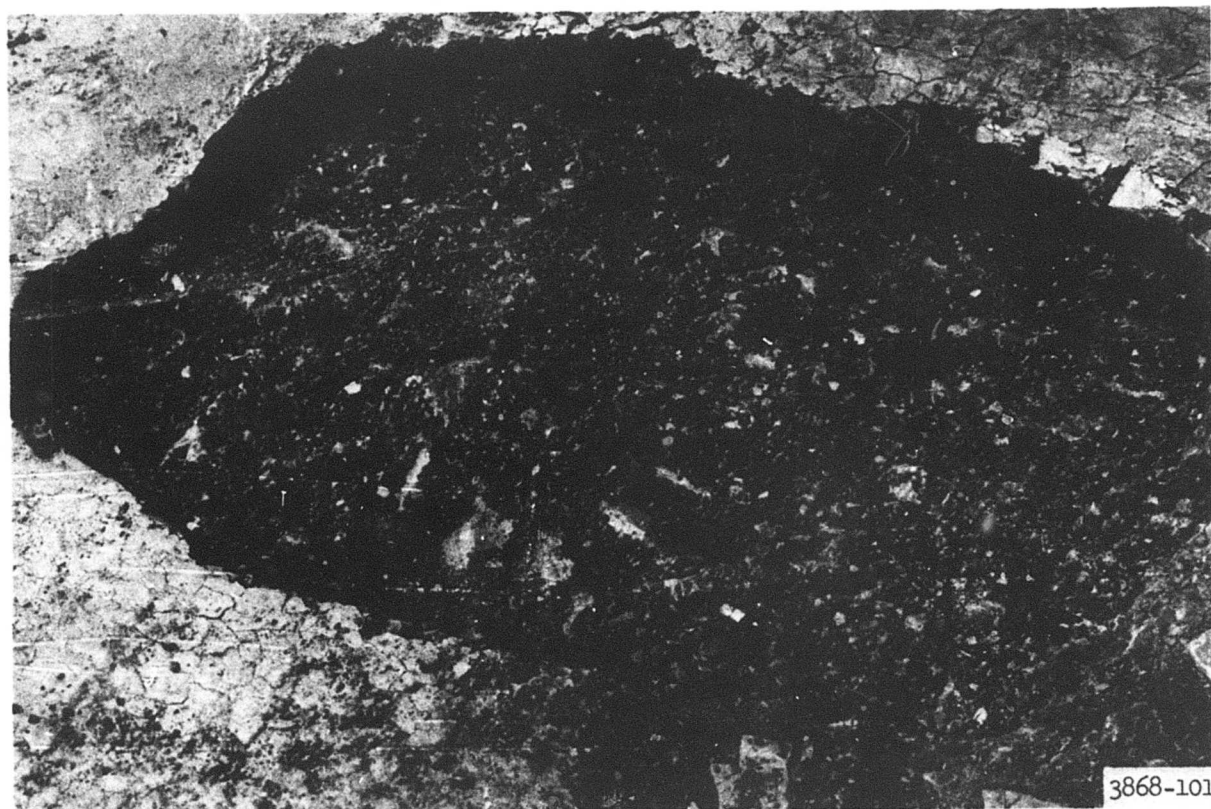
51. During the period 1-6 September, 40 additional coverages of traffic were applied to the test section, making a cumulative total of 280 coverages. During this time, minor repairs were required on the T1 membrane in item 1, and a previously failed area at the transition between items 5 and 6 was repaired. On 12 September, 22 coverages (cumulative total 302) were applied to the test section, with only minor difficulties occurring in item 6. All other items were in excellent condition. From 13-22 September, no additional traffic was applied; however, approximately 0.87 in. of rainfall occurred in the area. Inspection of the test section revealed that water had leaked through failed joints in the T1, T16, and T17 membranes, and localized soft areas were found in all items except item 4. In items 1 and 2, the T1 membrane and Griffolyn were removed, and the base was exposed for repairs (photograph 22). After base repairs had been completed, new T1 membrane was placed on the test section to replace the original T1 that had become irreparable due to a buildup of glue on the longitudinal joints. In item 3, the membrane was opened along a longitudinal joint, the base soil was removed and replaced, and the membrane was sealed. In items 5 and 6, several soft spots were repaired at this time. Photograph 23 shows an area in item 5 that had become wet due to leakage at a longitudinal joint, and photograph 24 shows the shallow depth to which repairs were required.

Photograph 24. Repair area in item 5 at 302 coverages. Wet soil has been removed and will be replaced with dry material

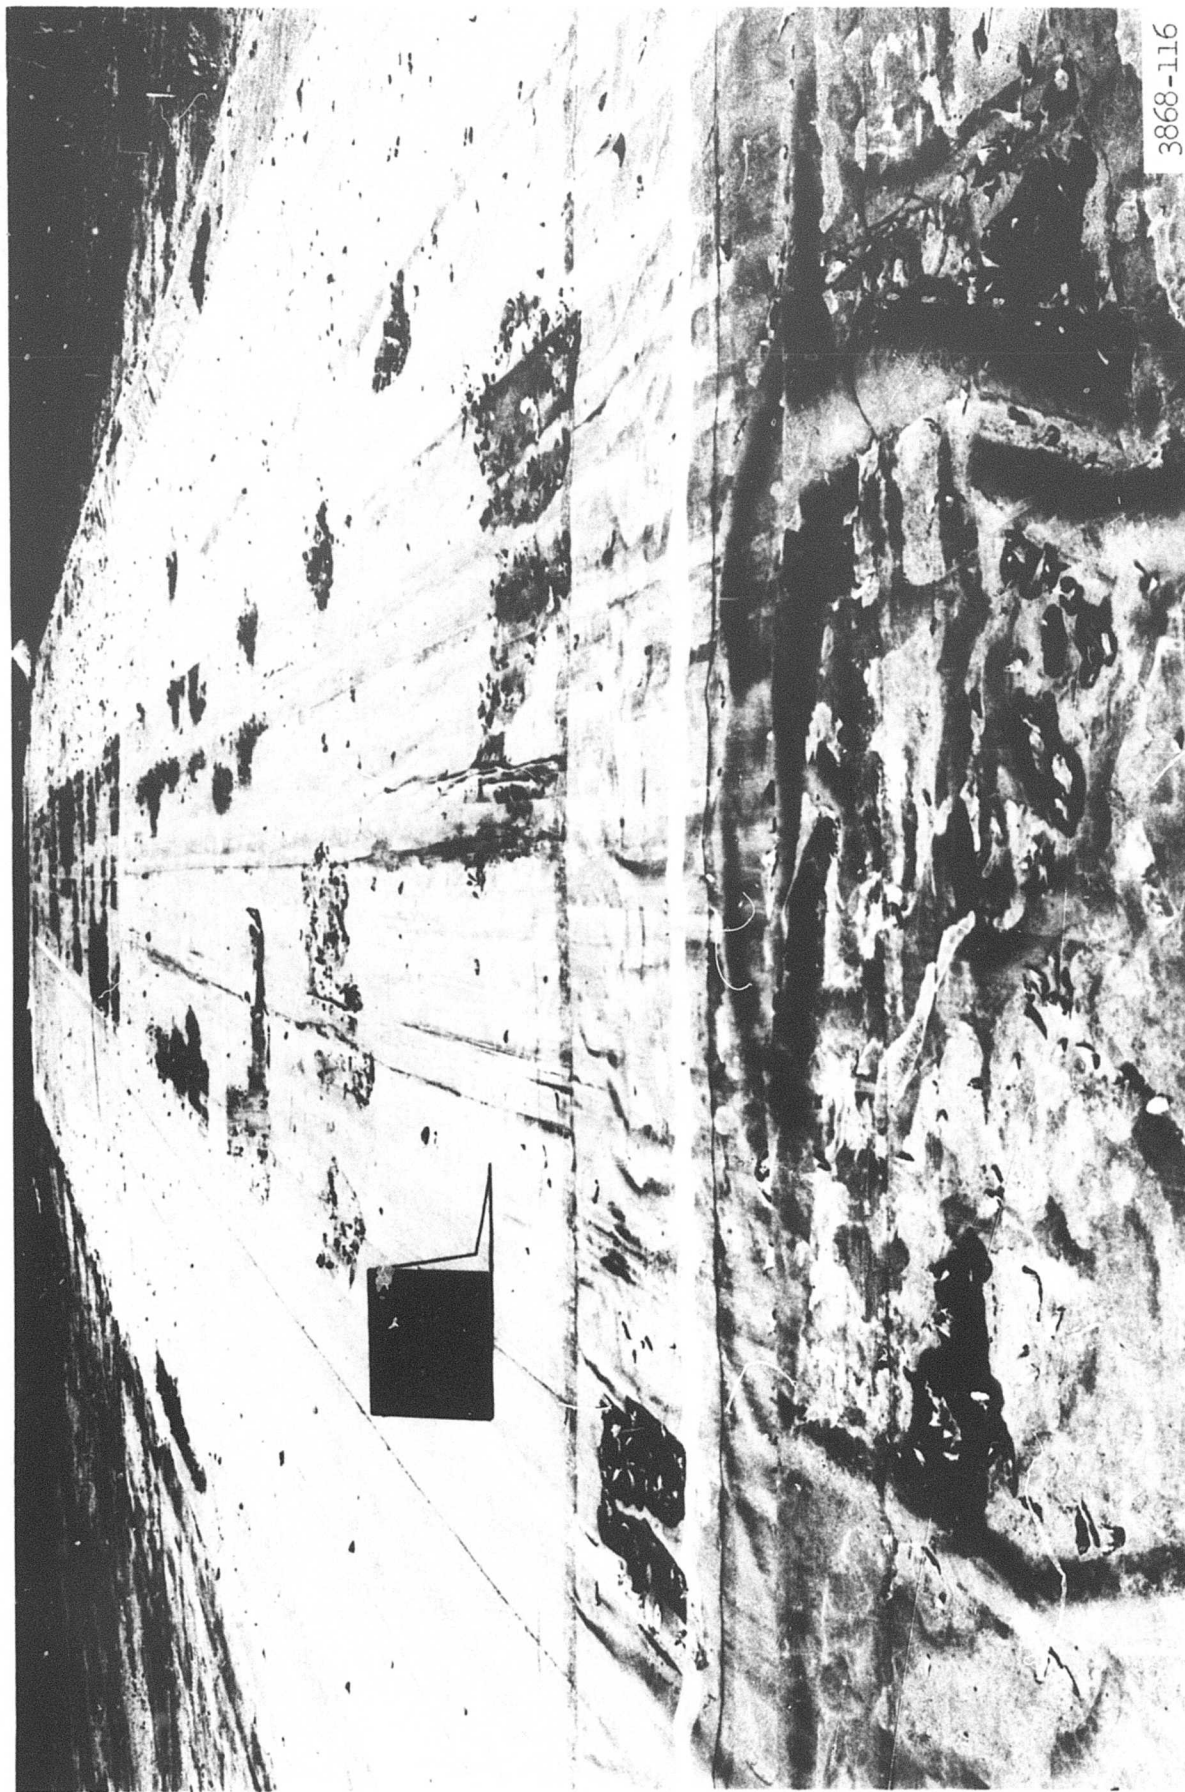
Photograph 28. Test section at 400 coverages after rain shower.
Note collection of water within traffic lane
